Wood-wasps producing short circuits.

By Poul Bondesen (Museum of Natural History, Aarhus, Denmark).

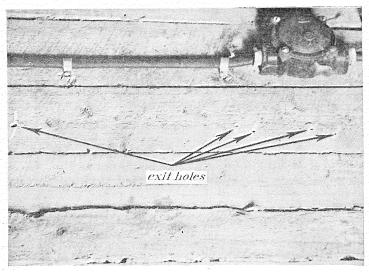
The occurrence had taken place at a farm situated at Hallendrup near Randers, and it was possible to localize the short circuit to an unarmoured lead cable fastened to the woodwork of a cowhouse. A burned spot about 25 mm in diameter was disstinctly seen on one of the deal boards close to the electrical cable. By removing this cable the characteristic exit hole of a woodwasp appeared (fig. 1). A closer examination of the deal boards showed a great many exit holes varying in size from 4—6 mm's diameter most of them placed in the middle of the 20 mm thick boards (fig. 2). The deal boards were placed in the stable during the summer of 1948. After being kept in a laboratory room for a few days a piece of wood perforated by the insects developed a high degree of convexity probably on account of fresh wood now getting desiccated. By cutting the cable open the insect was shown to have perforated the following sheets of insulation (cfr.

Fig. 2: Part of the deal boards covering the walls of the stable. Electrical cable and five exit holes of wood wasps are seen.

take quite a long time, about six years according to Boas (1923). To prevent an occurence such as a shortcircuit produced by the boring of a wood wasp, wood desiccated during a long period should be used, special attention being paid to the occurrence of living larvae or pupae of wood wasps. To use unarmoured lead cables fastened to deal boards may well be risky, and the above mentioned farmer has therefore changed the whole instalment in his stable.

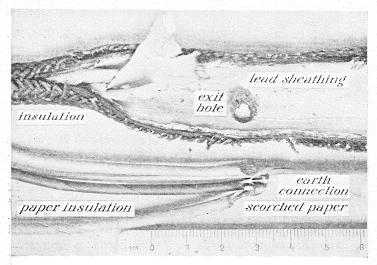
fig. 3): 1: A $1\frac{1}{2}$ mm thick envelope made of plaited paper strings saturated with pitch. 2: A 0,9 mm thick lead sheathing. 3: A one layer paper envelope containing three insulated wires. 4: Finally the insect has gnawed through the paper envelope and the 0,6 mm thick caoutchouc layer surrounding the single wires. In the three poled cable only the negative and the positive wires were damaged, while the third one—the earth connection (black wire in the middle, see fig. 3) was not gnawed at all by the insect. All this insulating material has no doubt been pierced by one and the same boring. The resulting short circuit has scorched the paper inside and outside the lead sheathing and melted the lead that frames the hole.

Fig. 3: The cable is cut open to show exit hole piercing the lead sheathing and the insulation of two of the wires, the earth connection (the black wire in the middle) not being touched.
